USAAVLABS TECHNICAL REPORT 68-82

DEVELOPMENT OF A CRASH-RESISTANT FLAMMABLE FLUIDS SYSTEM FOR THE UH-1A HELICOPTER

S. Harry Robertson

January 1969

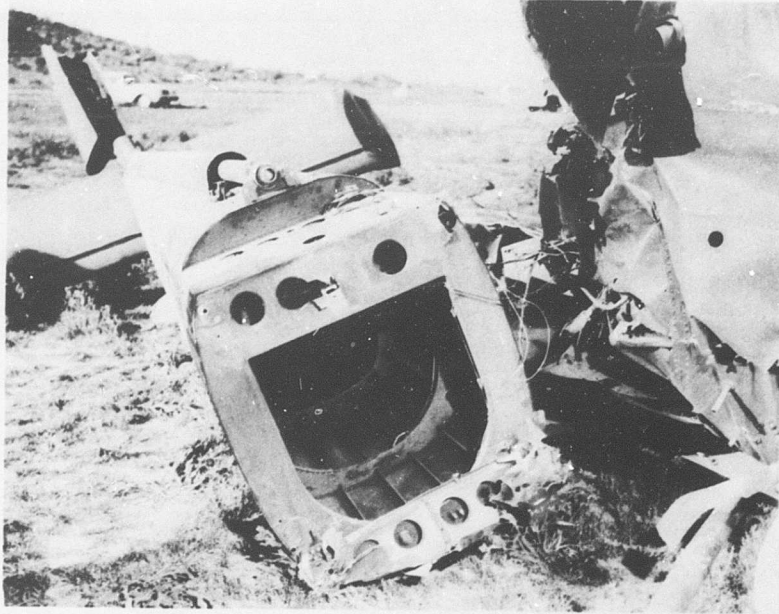
Figure 37. Tail Boom Broken From Fuselage.

The main rotor blades remained attached to the rotor head. The main transmission, as well as the engine, broke free of all mountings and displaced leftward, as shown in Figures 39, 40, and 41. Most of the cabin roof was torn free, and the fuselage broke, nearly separating, where the aft passenger compartment vertical bulkhead joins the floor; see Figure 42.

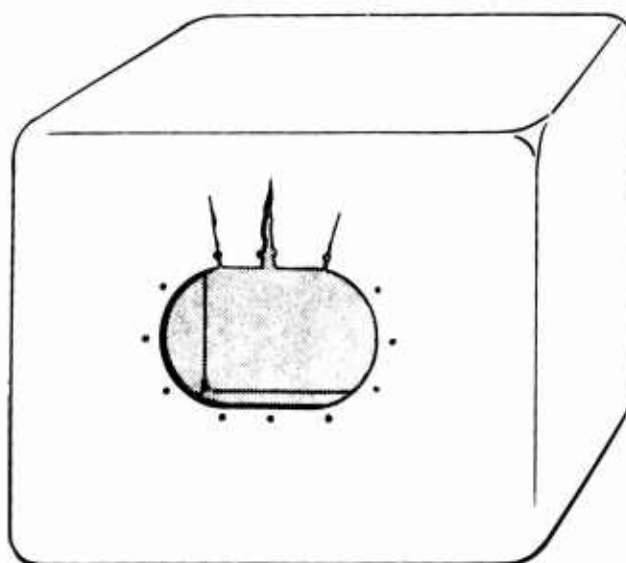
Figure 61. Tank Wall Failure as a Result of Overstressed Bearing Holes.

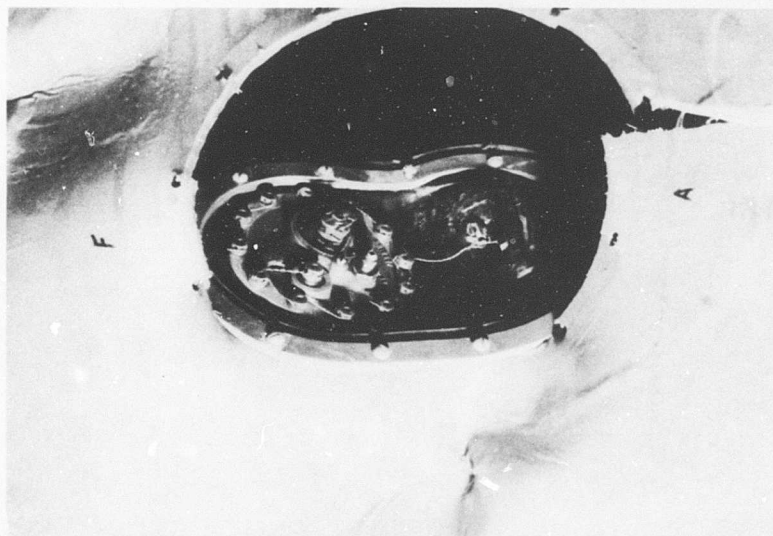
Figure 102. Damage to Boost Pump and Fuel Cell.

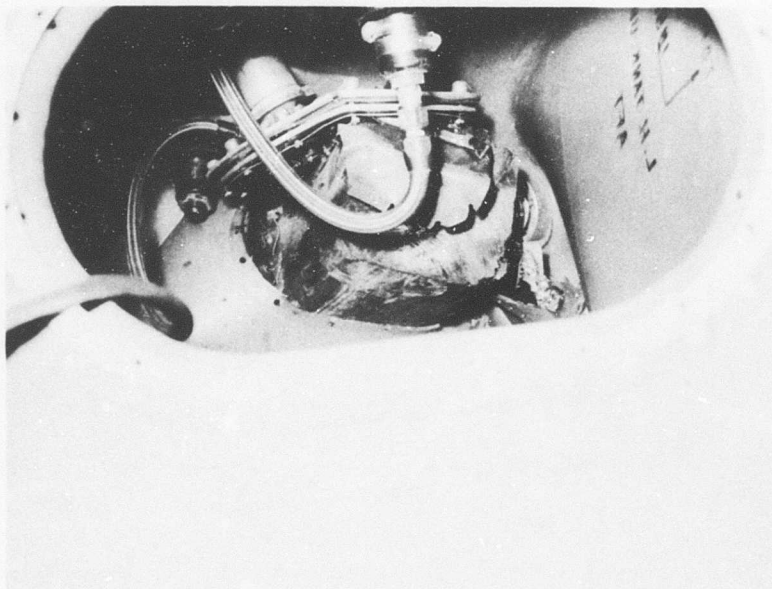
Figure 103. Railroad Tie Penetration Into Left Cell.
